## **"Full" Capital Funding Plan**

### **Lake Canyon Community Service District Los Gatos, CA**

**Report #: 34016-0**  
**For Period Beginning: July 1, 2018**  
**Expires: June 30, 2019**

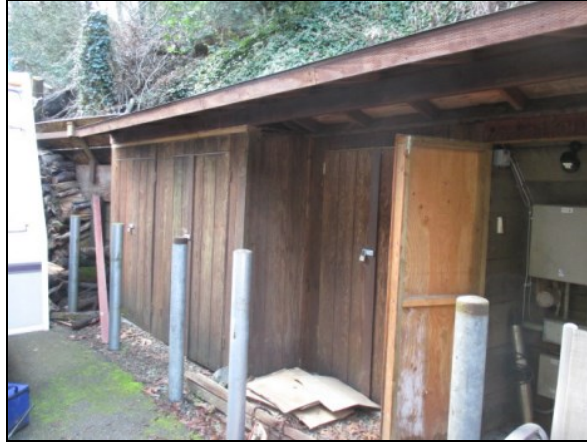
**Comp #: 301 Tank Enclosure - Repair/Replace****Quantity: (1) Enclosure**

Evaluation: This equipment enclosure stores the generators and main tank pump panels. The community plans to repair the enclosure in the near future. This component provides an allowance for repairs and/or replacement to the enclosure at the interval below.

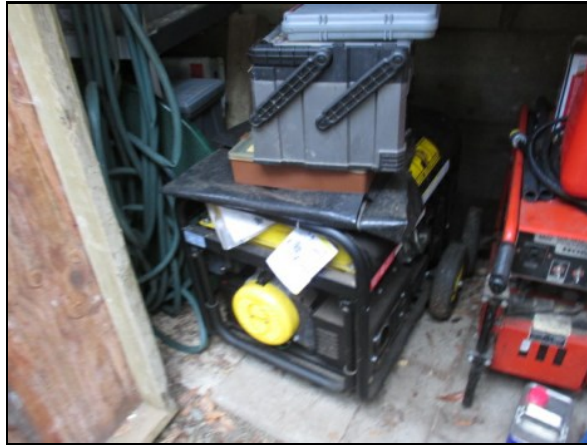
**Comp #: 302 Generator (B) - Replace****Quantity: (1) Champion Generator**

Evaluation: Age of the asset is unknown at this time. Have service vendor assess overall condition and if predictable basis for replacement or overhaul is determined, include funding within future reserve study update(s).

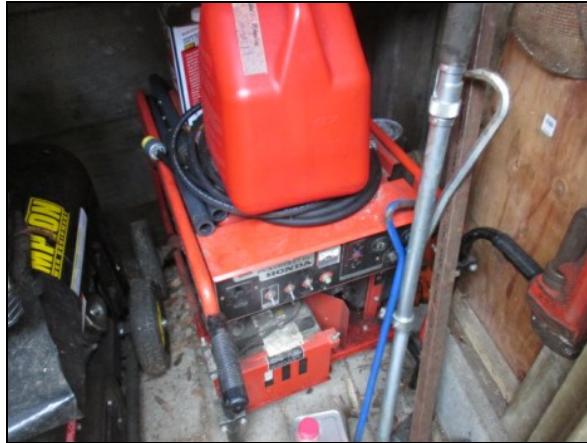
**Comp #: 302 Generator (C) - Replace****Quantity: (1) Honda Generator**

Evaluation: Age of the asset is unknown at this time. Have service vendor assess overall condition and if predictable basis for replacement or overhaul is determined, include funding within future reserve study update(s).

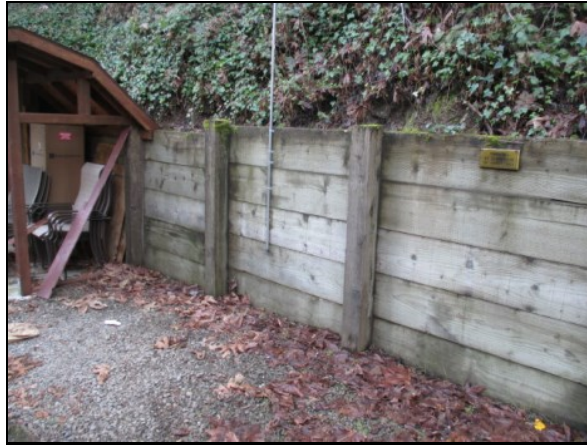
**Comp #: 514 Sluff Wall - Replace/Repair****Quantity: Approx 100 LF**

Evaluation: The sluff wall was upright at the time of the site inspection, however, the wall is showing signs of wood rot and decay at the base of the posts. We recommend consultation with a licensed professional contractor to help establish a viable repair and/or replacement plan.

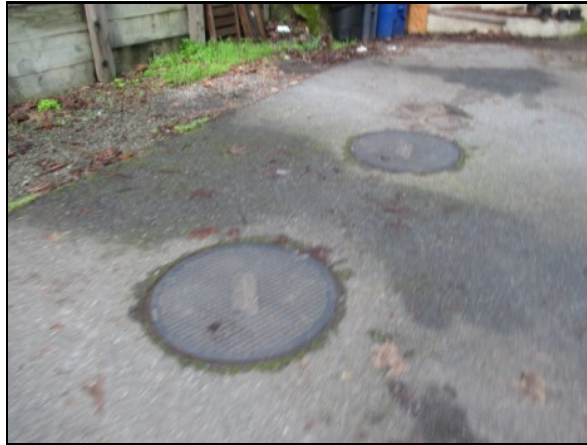
**Comp #: 1930 Main Pumps - (Partial) Replace**

Evaluation: This component provides an allowance to replace (2) pumps at the interval below. We recommend periodic inspections by a licensed professional to ensure the surfaces ages correctly.
